UMBRIA
MOBILITÀ

International Meeting on Road Safety and Marking

M5.3 – Improvement of bus stops environment

4 Renaissance & Più Sicurezza case studies

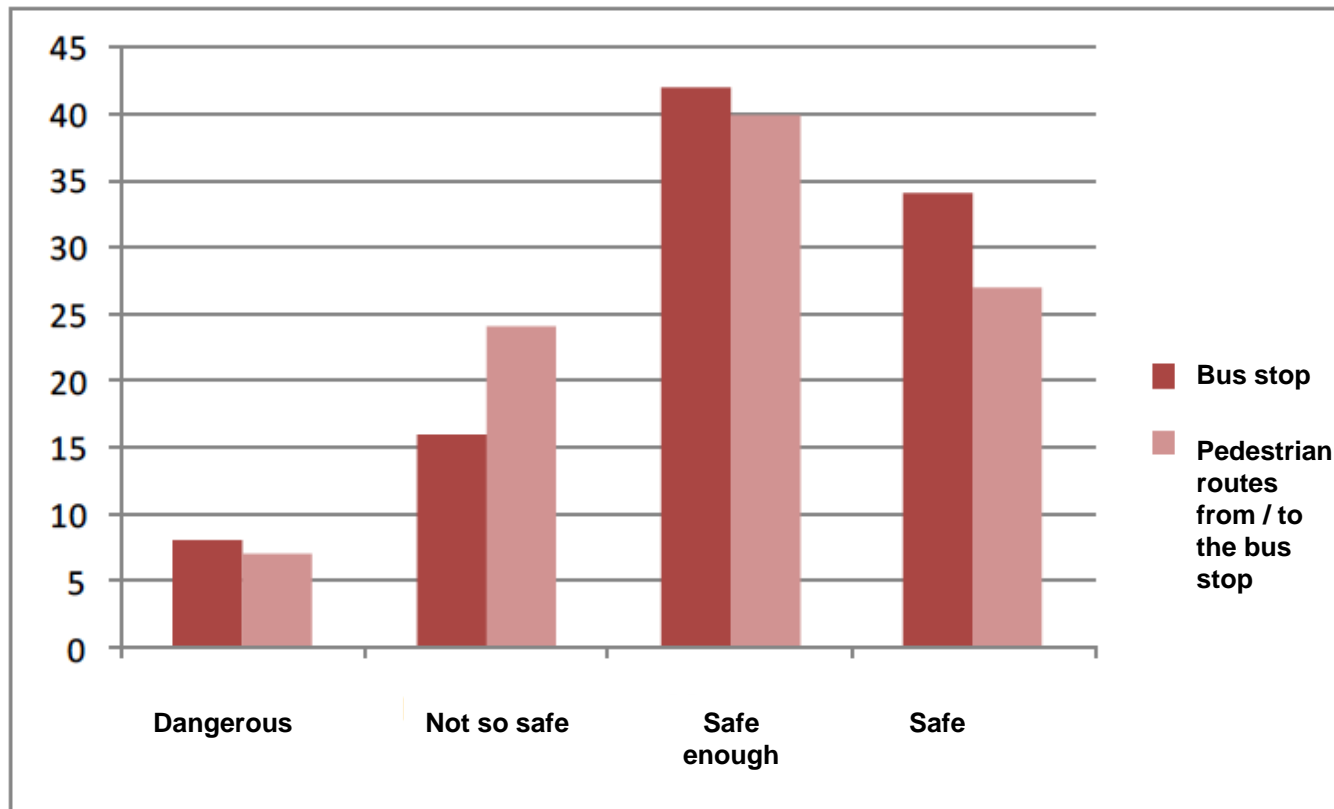
Main results

Source: Progetto Più Sicurezza, Analisi delle fermate del TPL Agosto 2010, DITS Sapienza università di Roma

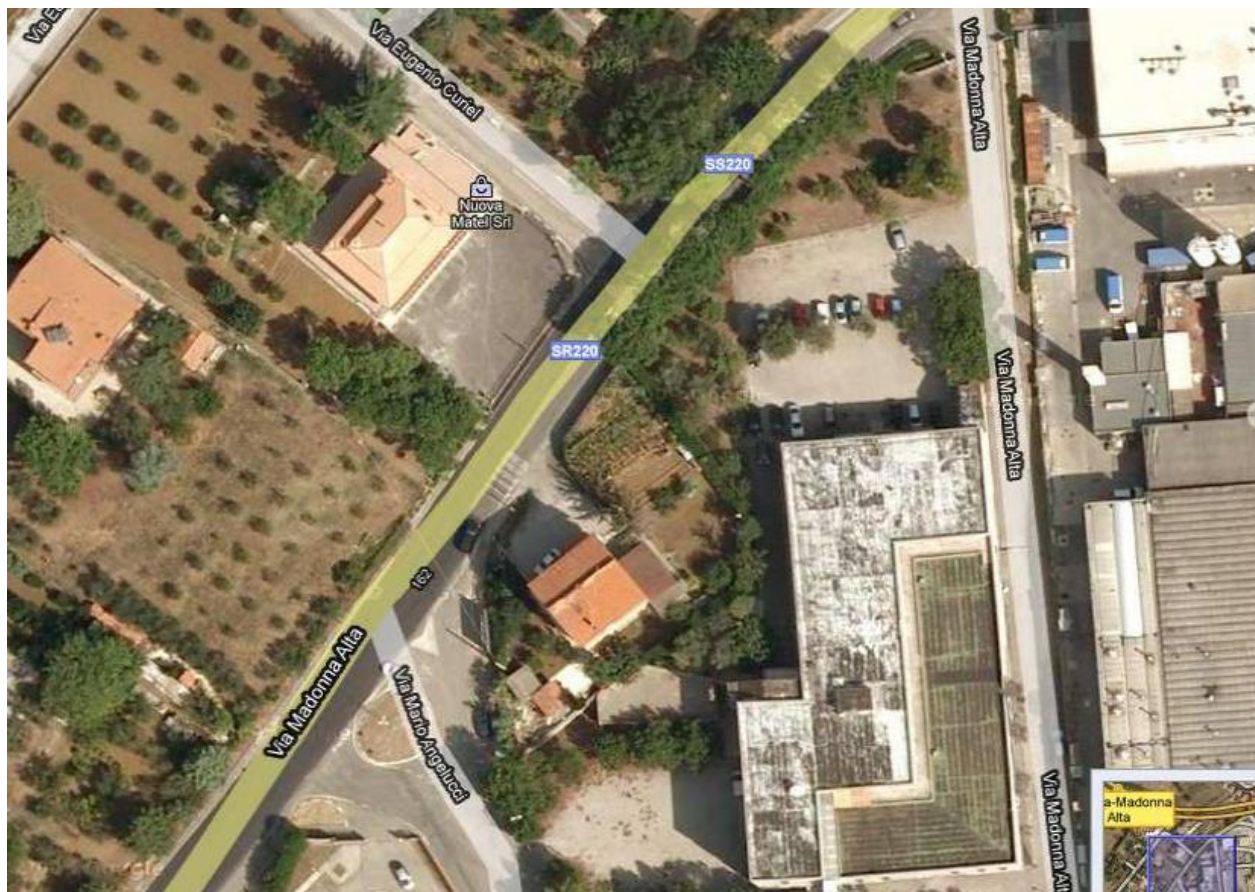
PG4014 – Madonna Alta

SAFETY AUDIT

- The bus arriving at the bus stop is an obstacle to the visibility for private cars. Absence of the bus shelter.
- Narrow waiting area inadequate to host bus customers. This bus stop is serving two main high schools of Perugia. Presence of obstacles on the waiting area
- Pedestrian Crossing nearby a bend and next to an intersection. Pedestrian walk partially present.
- Difficulties in getting on and off the bus due to the small waiting area.
- Absence of road signs and marking identifying the bus stop
- The bus stop sign is turned towards the road, creating difficulties to the customers that may go on the road to read the bus scheduling

Shared perception of risk by the customers, due to the high speed of private vehicles and to the narrow waiting area. Another major identified criticality concerned the difficulties in crossing the road.

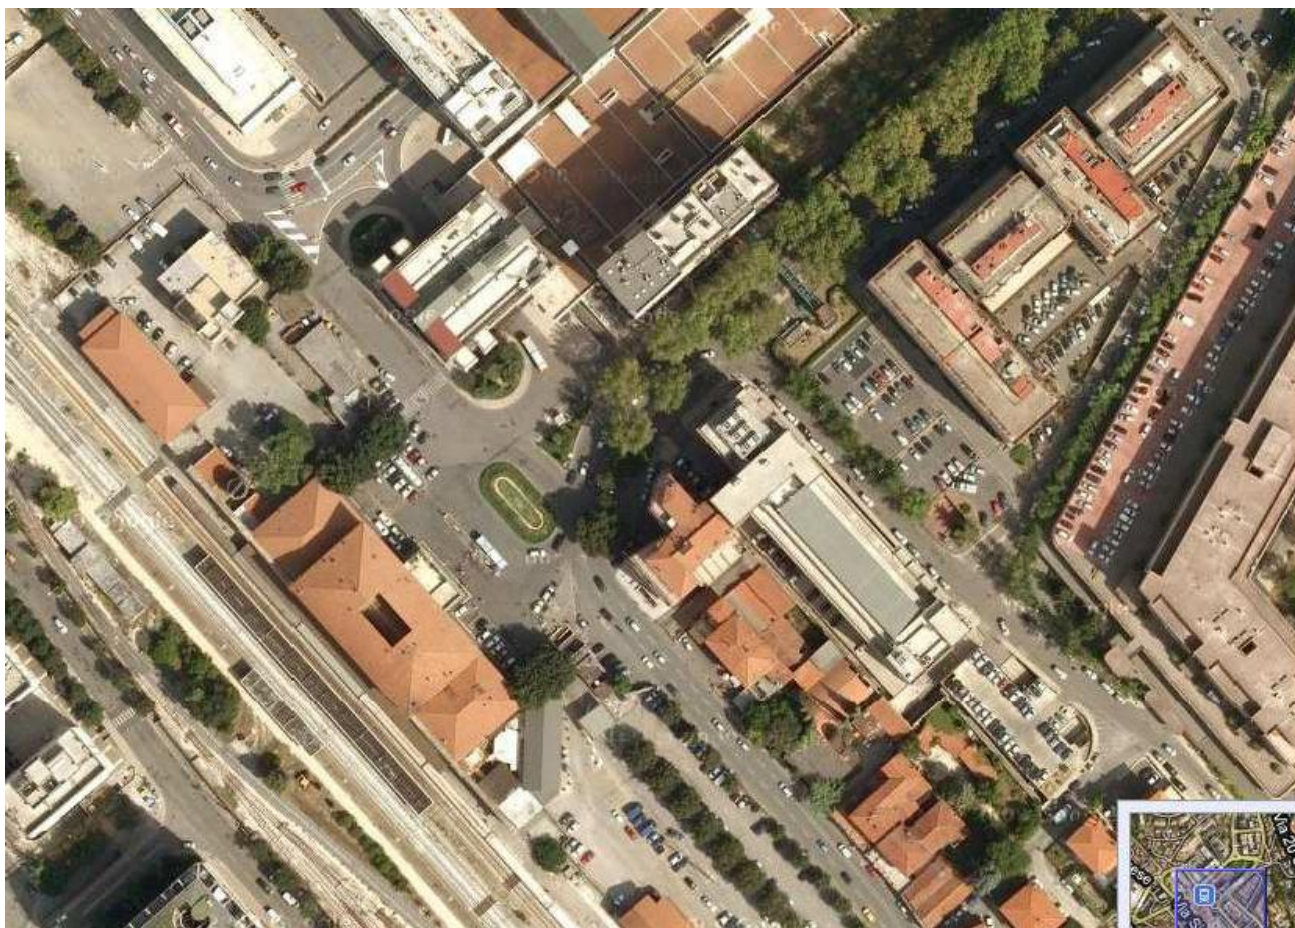
PG4079 – Fontivegge – Train Station

SAFETY AUDIT

- Absence of the bus shelter and of pedestrian crossing
- The bench on the waiting area is an obstacle to the pedestrian flow on the area. Presence of subsidence impeding the access to customers with reduced mobility
- Absence of pedestrian walks for accessing and leaving the bus stop waiting area
- Presence of barriers making scarcely visible the PT customers on the waiting area
- Absence of road marking identifying the bus stop and of pedestrian crossing. The bus stop sign is turned towards the road, creating difficulties to the customers that may go on the road to read the bus scheduling
- Difficulties in getting on and off the buses when all the three bus waiting areas were occupied

Shared perception of risk by the PT customers, due to the speed of vehicles and to the small waiting area. Another major identified criticality concerned the difficulties in crossing the road.

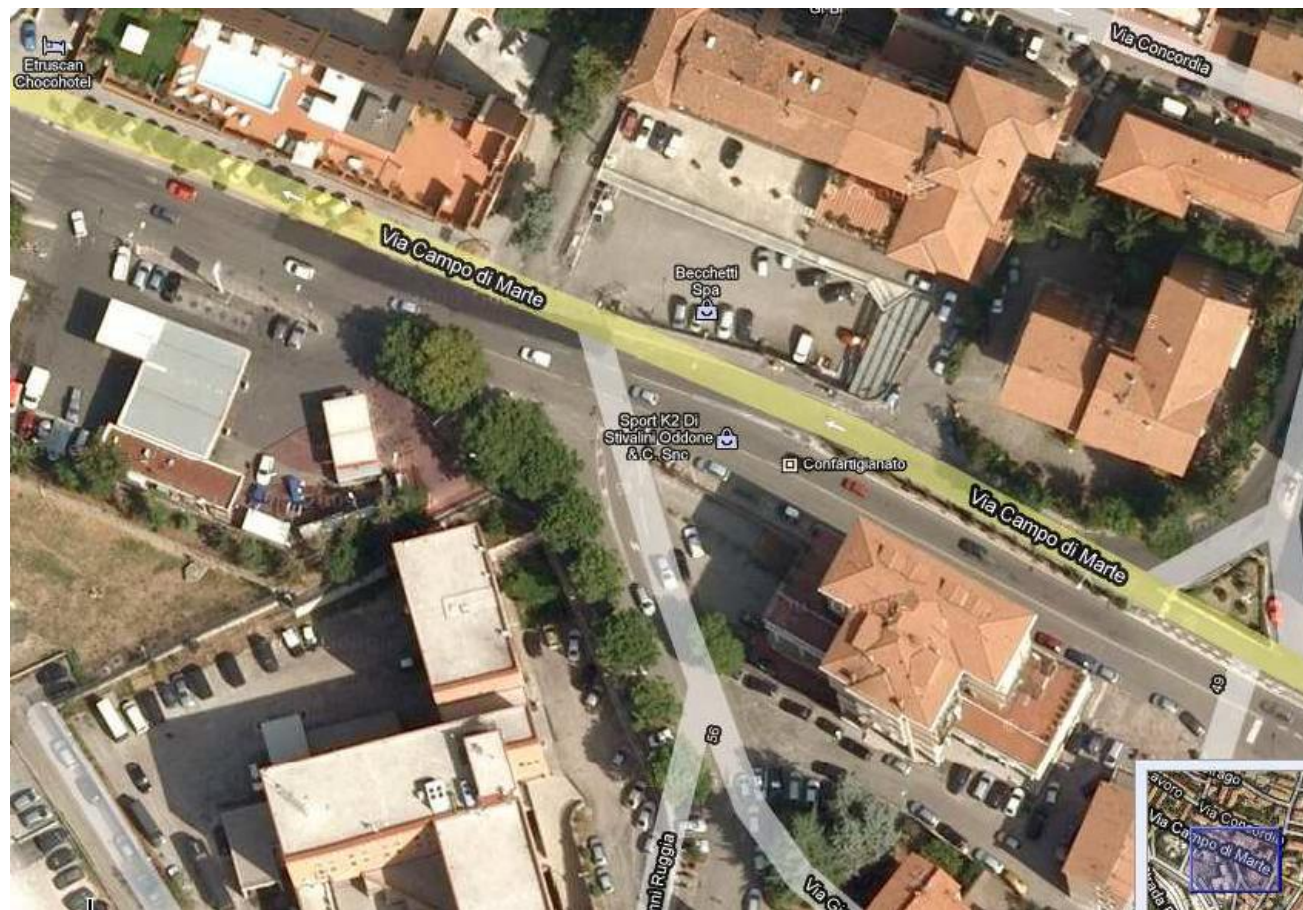
Case study n. 3 – Ex-ante status

PG4183 - Via Campo di Marte

- A – Inappropriateness of the bus stop location. The only pedestrian crossing is 150 m far from the bus stop. In case of crossing in front of the bus stop makes the pedestrians not visible to vehicles. Absence of the bus shelter.
- B – The waiting area is on the road and very narrow.
- C – Several subsidence make the waiting area uncomfortable and may lead the pedestrians to move to even more risky areas
- D – Inadequate lighting and bus stop not visible
- E – PT customers visible only if waiting on the road
- F – The limited waiting area makes difficult to get on and off the bus.
- G – Inadequate road marking identifying the bus stop.

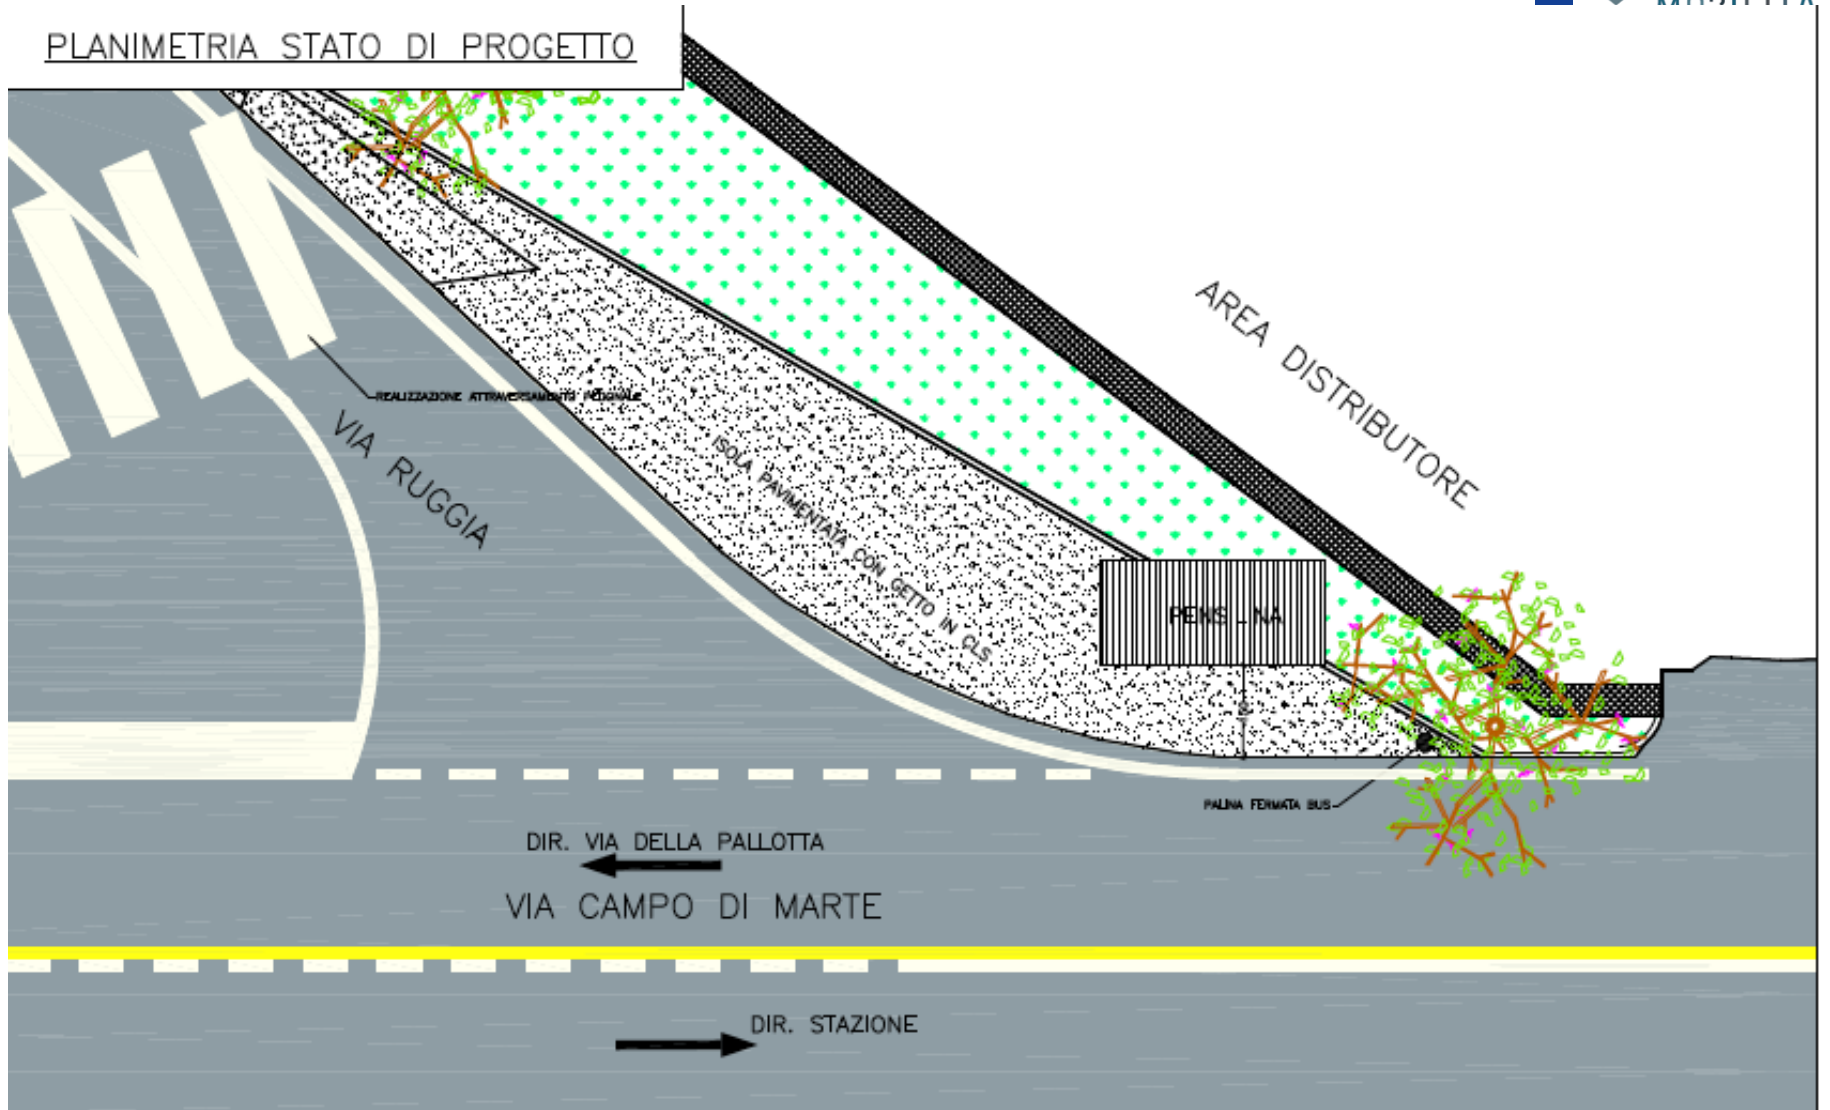
PLANIMETRIA STATO DI PROGETTO

Case study n. 3 - Technical planning

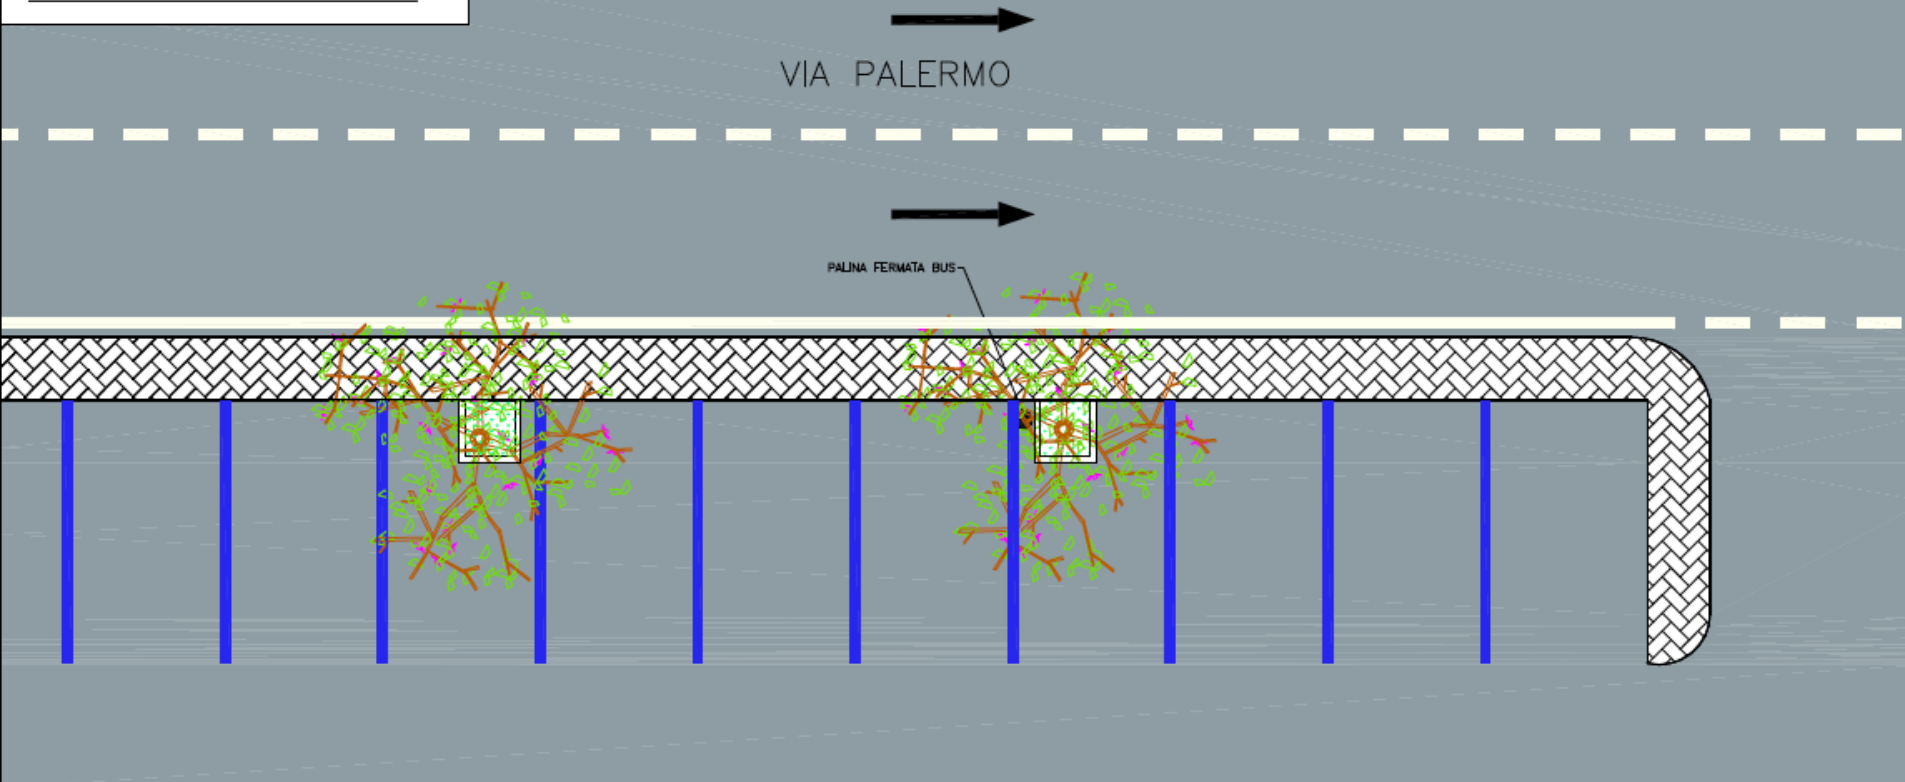
PLANIMETRIA STATO ATTUALE

Case study n. 4 – Ex-ante status

Key features:

- 3 bus routes
- Waiting area on the side walk
- Absence of bus shelter

SAFETY AUDIT

A – Absence of the bus shelter

B-F – The waiting area is narrow and inadequate for facilitating PT customers getting on and off the bus.

D – Inadequate lighting and bus stop not visible

G – Inadequate road marking identifying the bus stop.
