THE “MARIA REGINA DELLA PACE” CHURCH IN PERUGIA: ACOUSTIC MEASUREMENTS AND CORRECTION DESIGN

Cinzia Buratti*¹, Rita Mariani¹, Irene Costarelli¹

Abstract

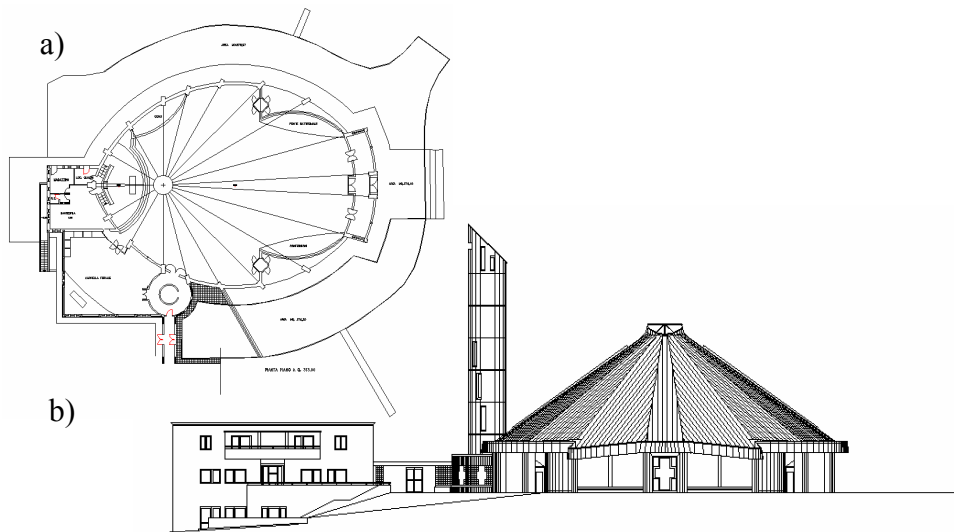
Fig. 1 – Plan (a) and front view (b) of the church

The presbytery corresponds to the fish head, the reunion hall to the body, the Spiritual Birth Chapel within the font is the right fin and the Rebirth Chapel is the left one; finally the solemn entrance is the tail. The church, viewed from the presbytery, has a curtain form; the big beams of the structure, viewed from the altar, enclose the reunion.

The “Maria Regina della Pace” church is located in Perugia, Umbria, Italy. The church building, started in 1991, was finished in 1993, so it is a modern church. The building architecture has many symbolic meaning: the church plan has a fish form, to remember the S. Pietro’s miraculous fishing; indoor structure is shaped upon this form, in compliance with the liturgical requirements.

Figure 1 shows the plan and the front view of the church.

Many architectural elements (floor, altar, ambo and font) are made of marble. The windows are made of blown glass, the pews of oak wood; the inner covering, which gave many problems in the modeling due to the ovoid form of the plan, is made of lamellar wood, while the external covering is made of copper.

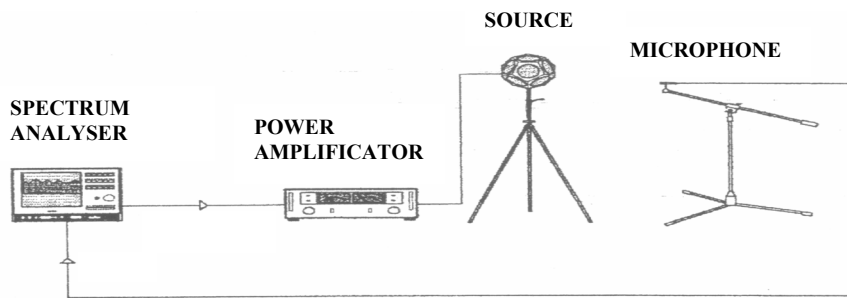
The MLS signal generated by Symphonie was amplified, emitted by a dodecahedral source and then it was take back by a microphone situated at 1,20 m from the floor.

Fig. 2 – Scheme of the experimental apparatus

The acoustic measurements reverberation time τ_{60} , clarity index C_{80} , definition index D, RASTI and STI were carried out through the Symphonie system by 01 dB – Stell, in compliance with ISO/FDIS 3382 [1]. Figure 2 shows a scheme of the experimental apparatus.

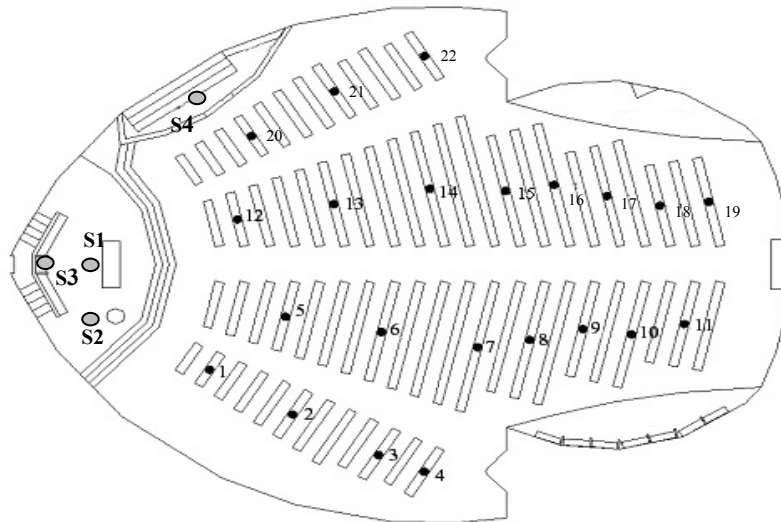
Measurements were carried out with 4 source positions and for each of them in 22 microphone positions, as showed in figure 3.

Fig. 3 – Measurement and source positions

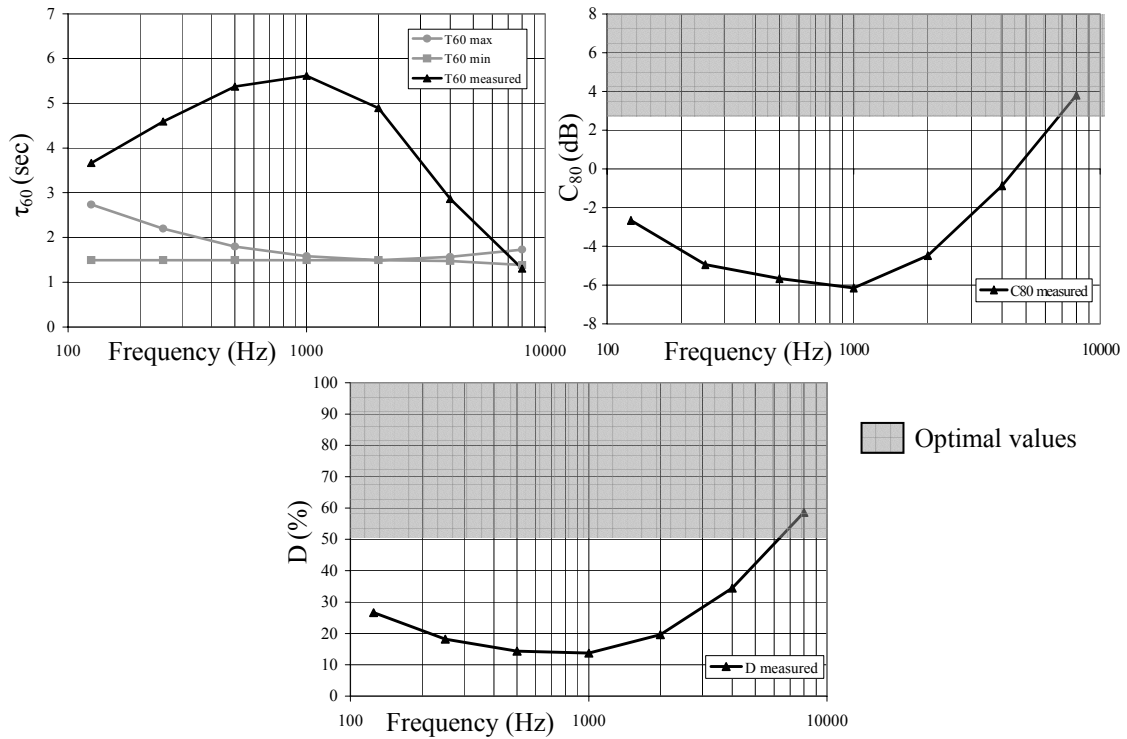
The optimal acoustic parameters for the church activities could be deduced from Literature [2], knowing the room volume (9.000 m^3); they are then compared to the measured data, in order to evaluate the acoustic quality of the church. Figure 4 shows the mean values of the measured parameters related to the source position n. 1 (behind the altar) and the comparison with the optimal ones when the church is used for speech listening. Figure 5 shows the mean values of the measured parameters related to the source position n. 4 (chorus) and the comparison with the optimal ones when the church is used is for music listenig. Table 2 shows a sinthesys of the measurements results.

Fig. 4 – Source position n. 1: optimal values for speech listening and mean measured ones

An important acoustic parameter, when the church is used for speech listening, is the RASTI index; the RASTI main value related to the source position n. 1 is 0,35, the corresponding RASTI acoustic quality class is “Low”.

Finally results show that it is necessary an acoustic correction to improve both the speech and the music listenig quality.

ACOUSTIC PARAMETER	COMPARISON WITH THE OPTIMAL RANGE
SPEECH (S1)	τ_{60}	TOO HIGH
	C_{80}	TOO LOW
	D	TOO LOW
	RASTI	TOO LOW
MUSIC (S4)	τ_{60}	TOO HIGH
	C_{80}	TOO LOW
	D	GOOD

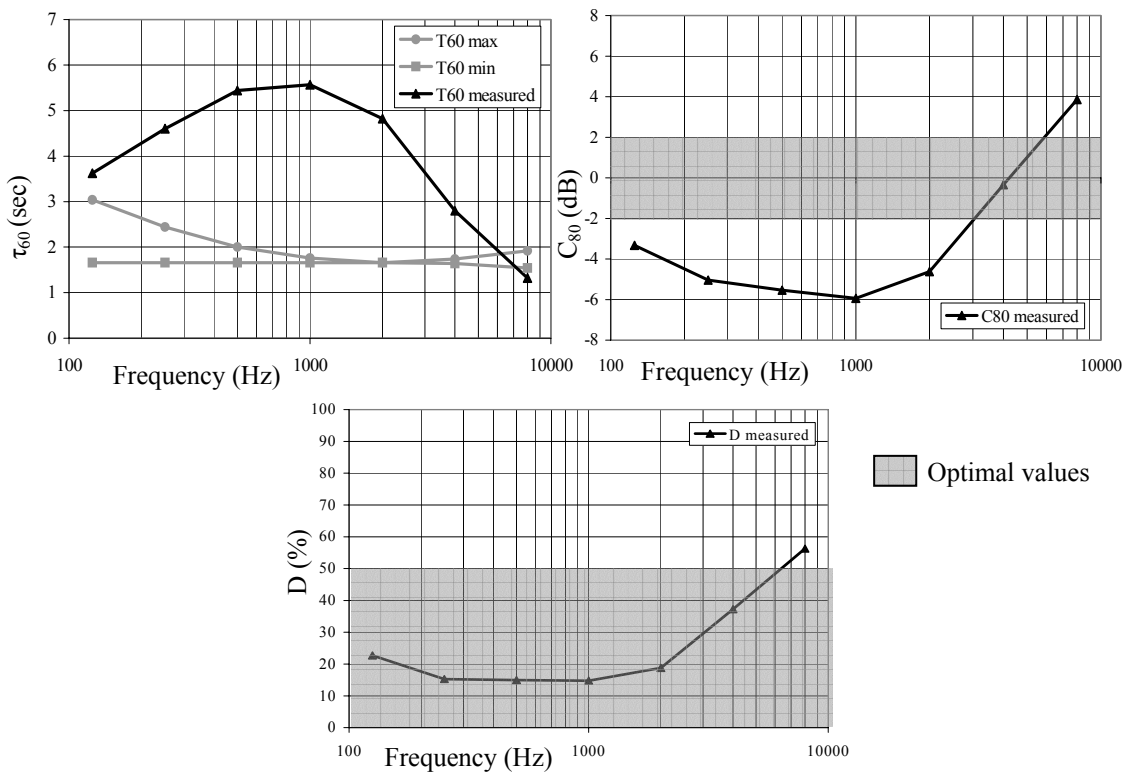
Fig. 5 – Source position n. 4: optimal values for music listening and mean measured ones

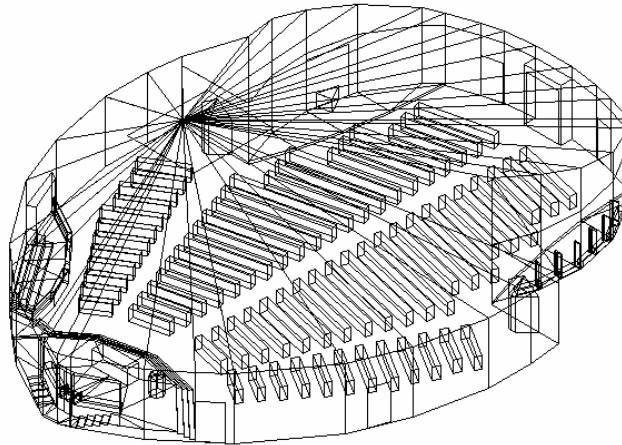
Table 3 shows the acoustic material properties inserted in the model and Figure 6 the 3D church model.

Fig. 6 – 3D church model

The acoustic simulation was carried out in the S1 and S4 source positions. To calibrate the model, the simulation results were compared to the measured values. As an example, Table 4 shows the calibration results in S1.

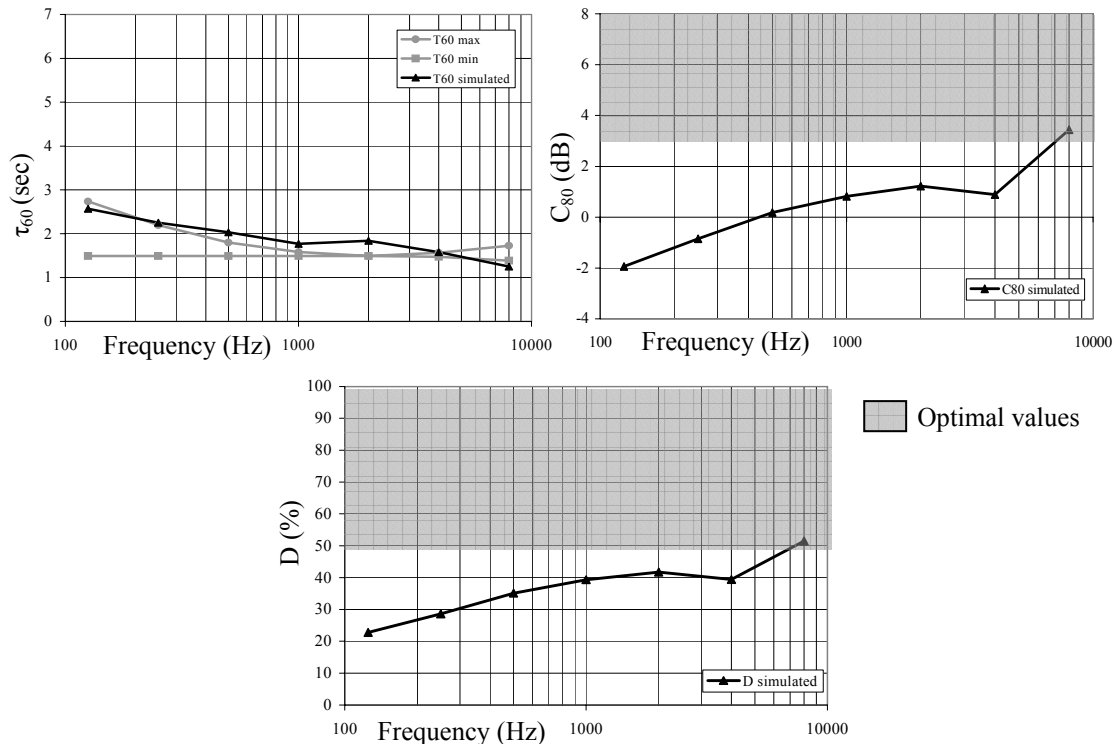
After the simulation, the acoustic parameters obtained in S1 and S4 source positions were analysed. Figure 7 and 8 show the related mean acoustic parameters and the comparison with the optimal range.

Fig. 7 – Source position n. 1: optimal values for speech listening and simulated parameters

In S1:

- τ_{60} is quite good in the considered frequency range;
- C_{80} and D are still low, but there is an improvement of 55% and 65% respectively with respect to the measured values;
- the RASTI mean value is 0.35, so there is not any improvement.

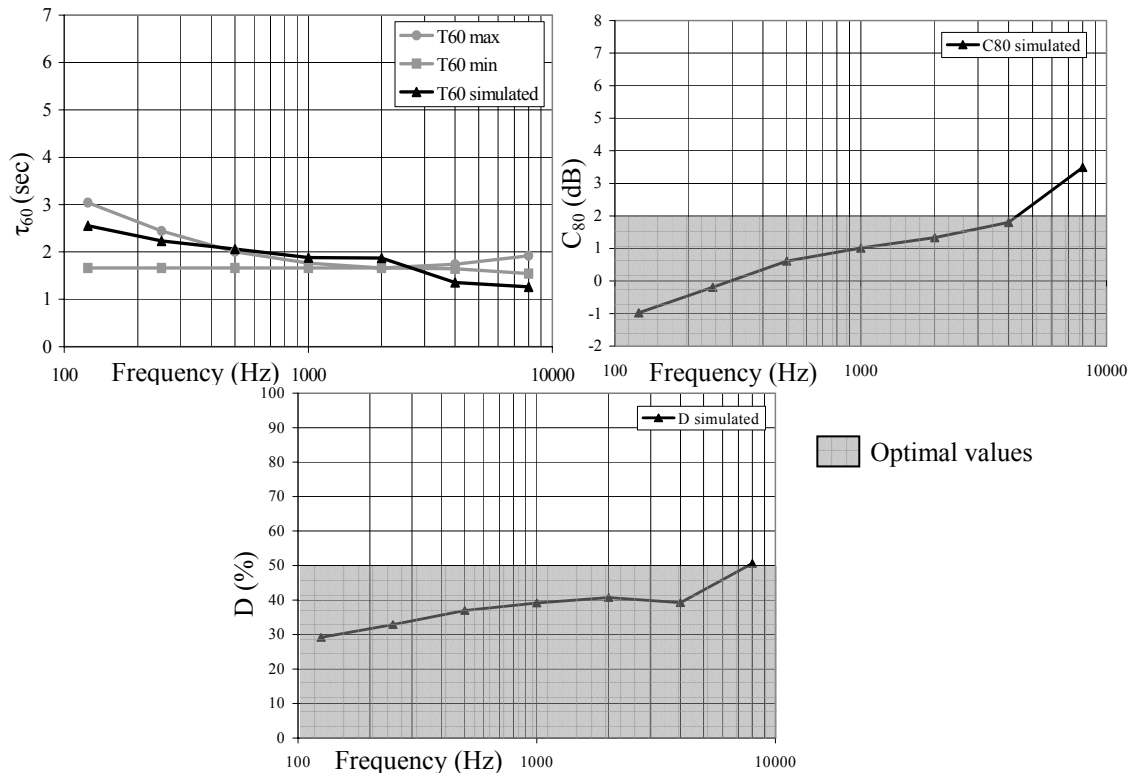
Fig. 8 – Source position n. 4: optimal values for music listening and simulated parameters

In S4:

- τ_{60} is quite good in the considered frequency range;
- C_{80} and D are acceptable in all frequencies range, except at 8000 Hz.
